HISTORIC STRUCTURE REPORT
- ARCHITECTURAL DATA SECTION
FORT MOULTRIE

FORT SUMTER NATIONAL MONUMENT

CHARLESTON
SOUTH CAROLINA

By
John C. Garner, Jr.
Historical Architect

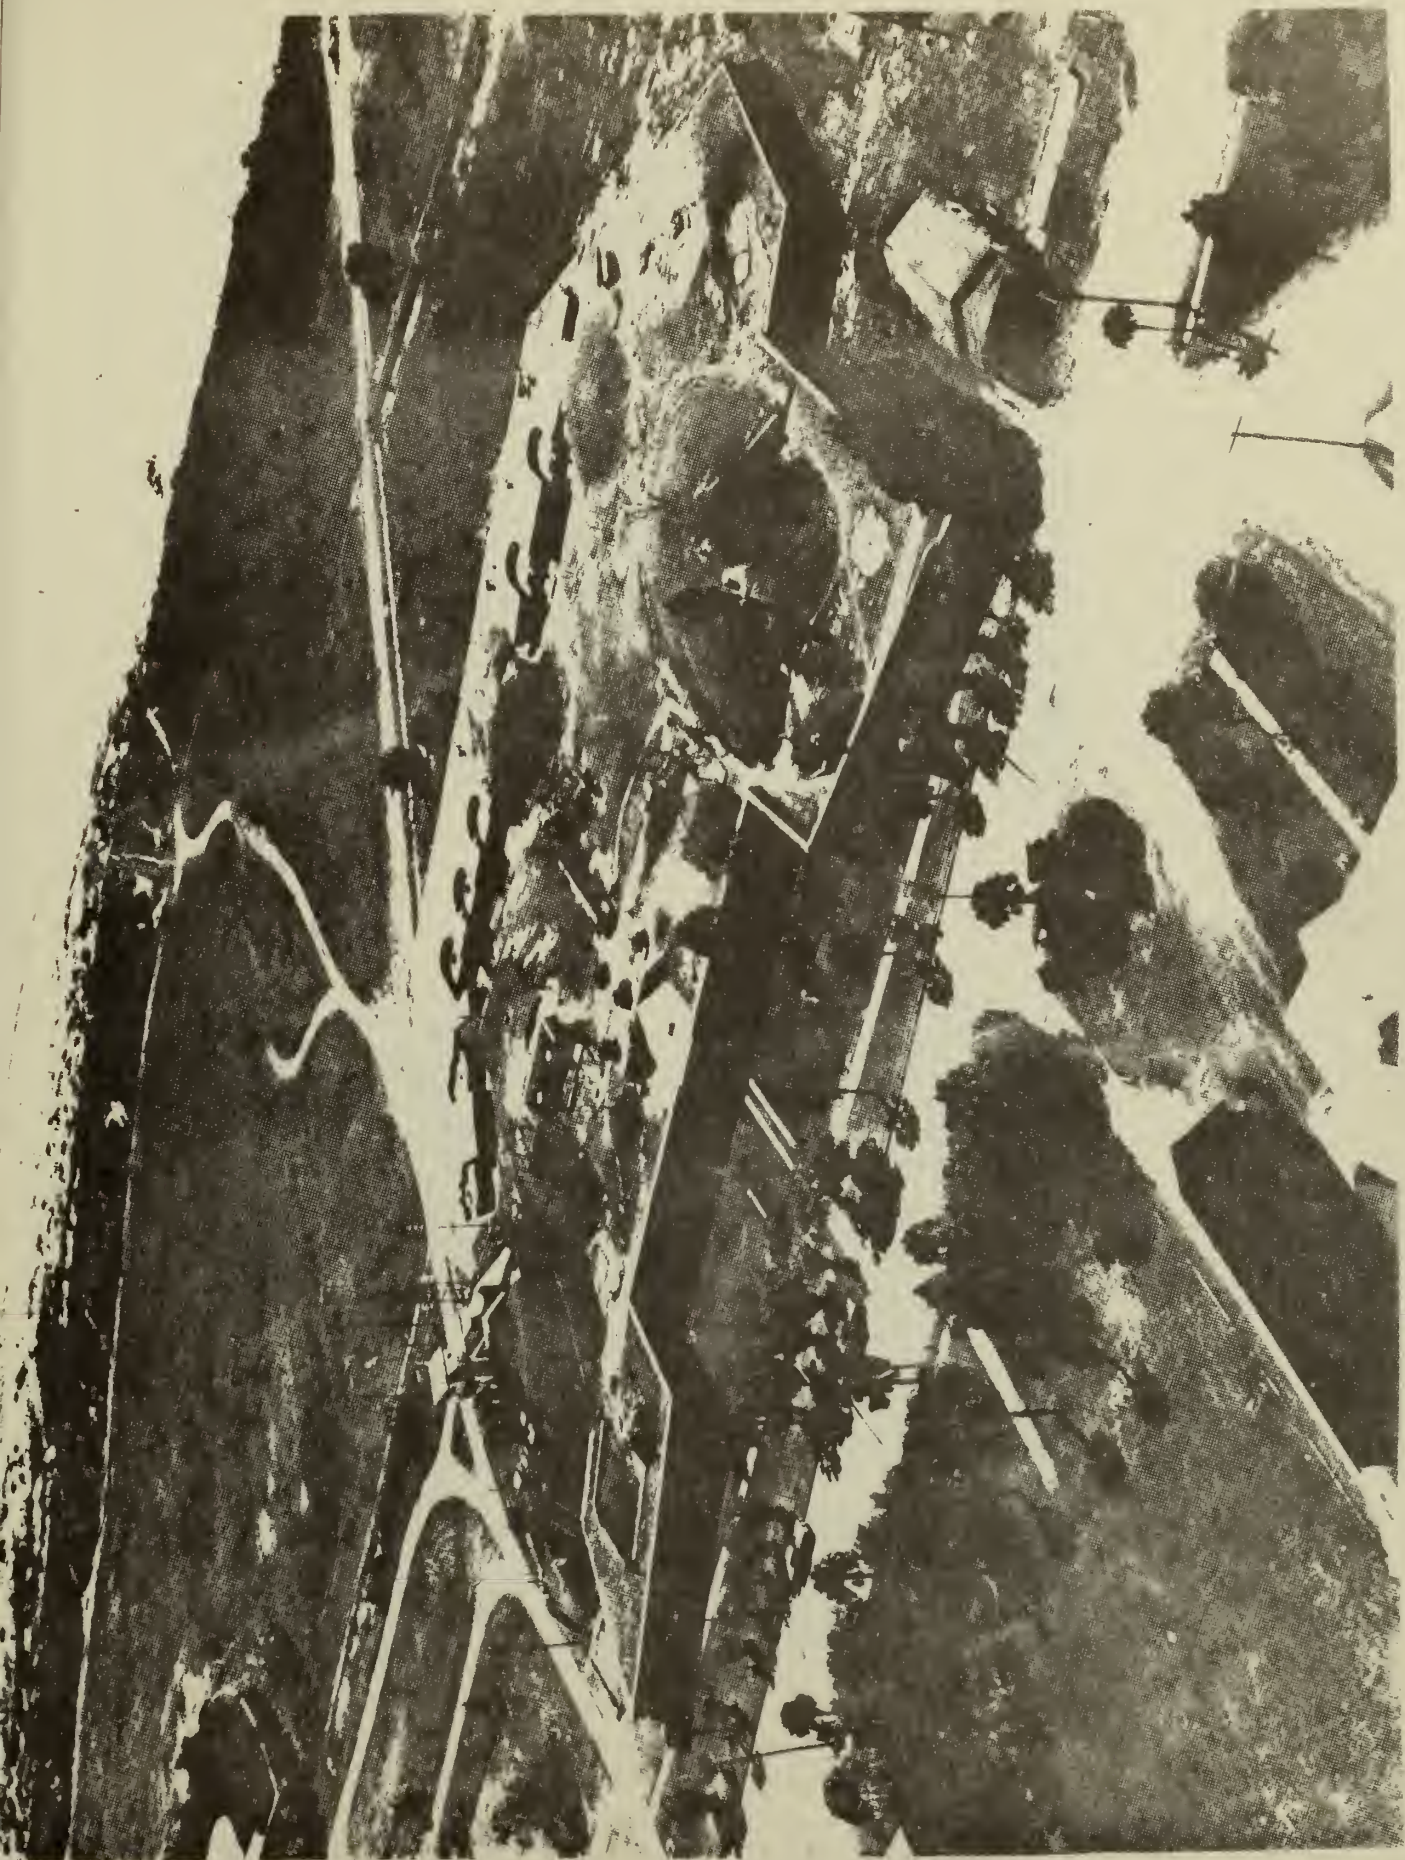
PHOTO I

The present fort, including all of its components, is in good condition. (Photo 1) The brick are hard burned units and very few have noticeably deteriorated. The northeast angle of the southeast salient has separated from the wall and needs repair but there are no serious structural faults to be found in any of the historic fabric. (Photo 2)

Aerial View - Fort Moultrie

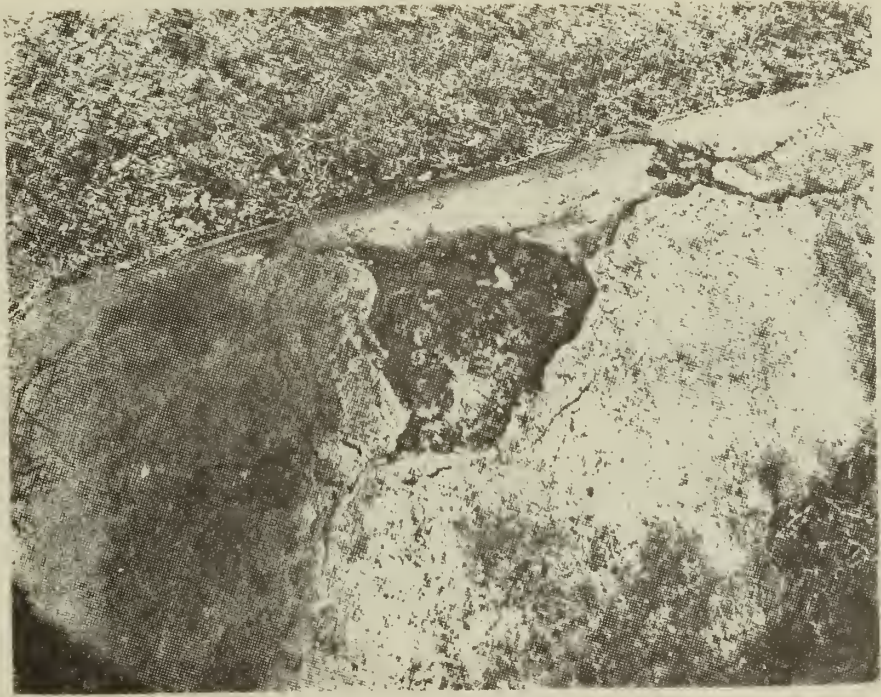
The brick and granite aggregate concrete roofs of the Sally Port have suffered deterioration of the surfaces, leaving them rough and exposing the aggregate. (Photo 5) Wherever any of the other underground structures' roofs have been exposed to the weather through loss of the super-incumbent earth cover, the concrete surface has eroded and deteriorated. (Photo 6)

PHOTO 6
Surface Deterioration of Exposed
Service Magazine Roof

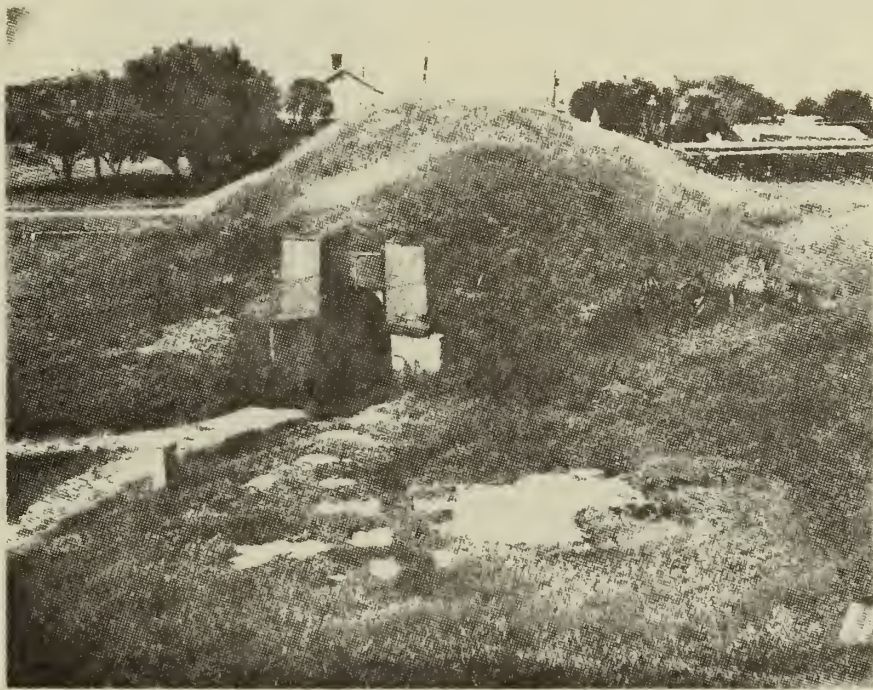
PHOTO 7

Northeast Service Magazine

Note Surrounding Slopes which Cause Water to Flow into Magazine

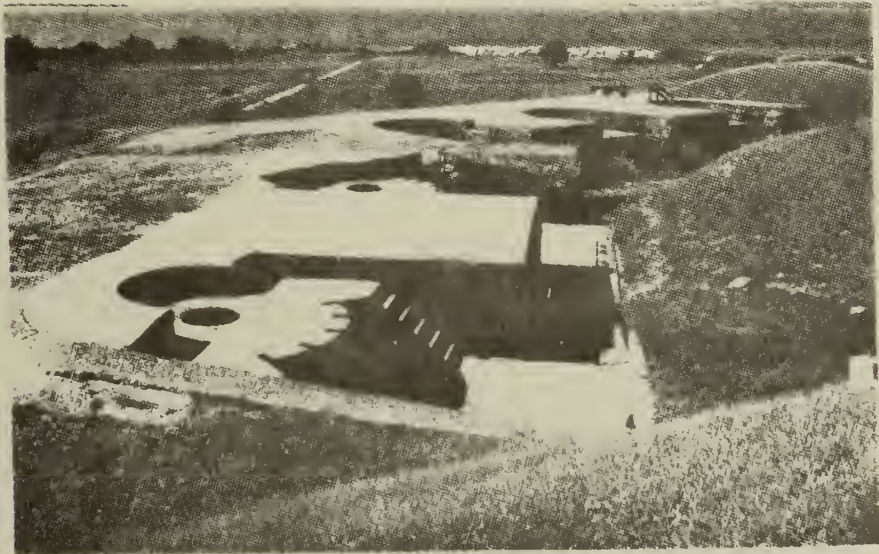
Of the three Endicott Batteries (Battery Bingham, Battery McCorkle and Battery Lord), Battery Bingham is in the best condition. (Photo 9) All of the exposed steel and iron work is in very good condition, well painted and smooth surfaced, showing few signs of corrosive action. (Photo 10)

PHOTO 9
Battery Bingham in Foreground
Battery McCorkle in Background

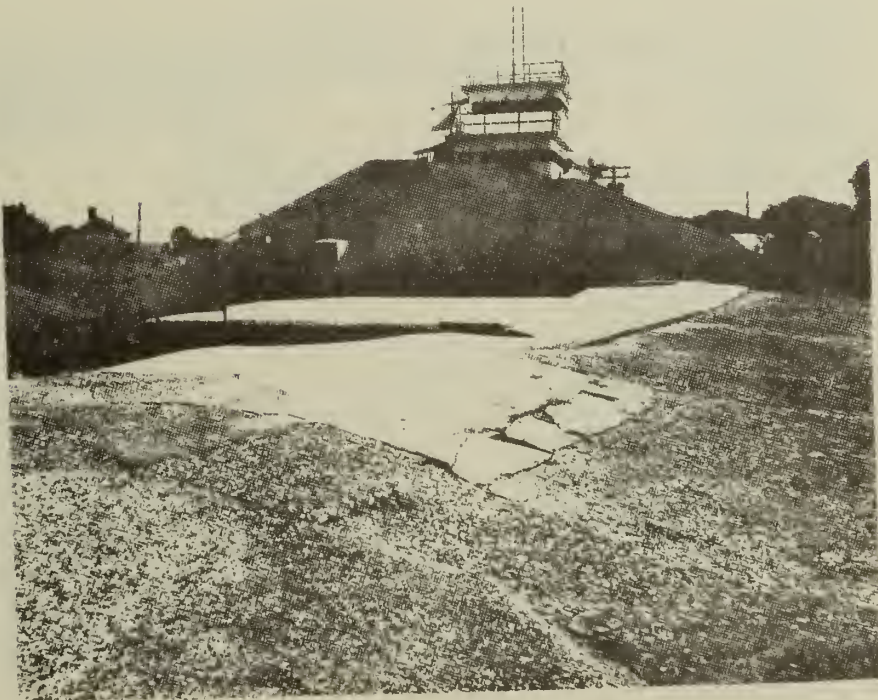
The concrete of this battery is in good condition. The surfaces are generally sound and smooth, although broken by numerous but insignificant hairline cracks and exhibiting minor surface spalling. The concrete blast apron is in fair condition. There has been subsidence and cracking and the entire surface has eroded, exposing the granite aggregate. (Photo 11)

PHOTO 11
Battery Bingham and Blast Apron
Note Surface Deterioration, Cracking and Subsidence,
HECP/HDCP in Background

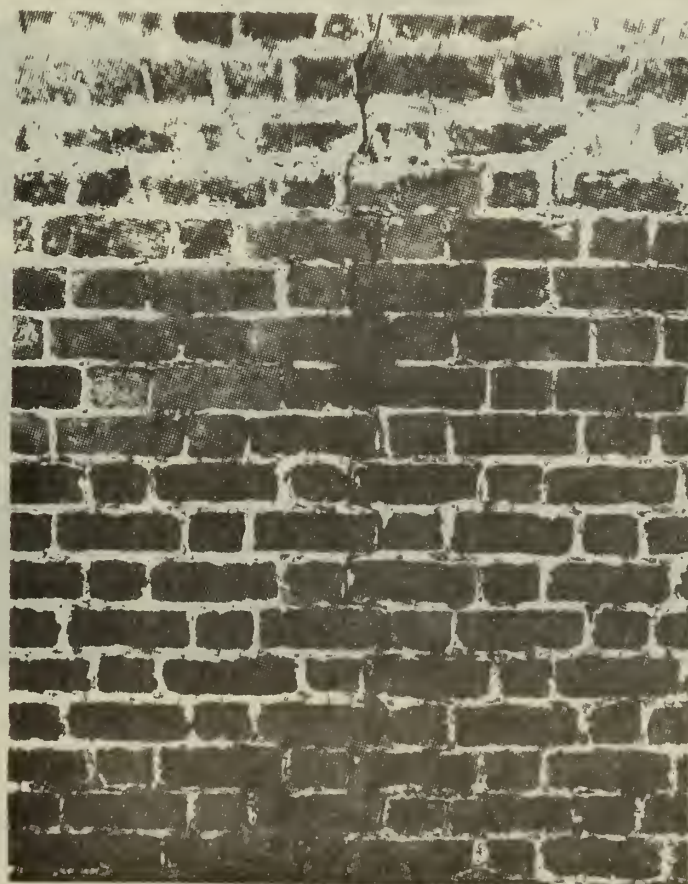
The only visible remains of the original enceinte of Fort Moultrie are the scarp walls. (The parapet or coverline walls, parade walls, counter-ports and tie walls were removed in 1872.) Foundations of the walls, 7'6" wide, were erected on a double layer of thick plank which, over the years, has decayed and allowed differential settlement. This settlement has produced wall cracks but repointing efforts dating back to the 1830's have held the damage to a minimum. At present bond separation is evident but in every case the soft lime mortar has allowed for slight movement without damage to the brick units. (Photo 21)

Mortar joints are generally good with the exception of the north faces which require extensive repacking of the joints and repointing. The scarp walls are otherwise in fair to good condition.

PHOTOS 21 and 21-A
Typical Condition of Scarp Walls

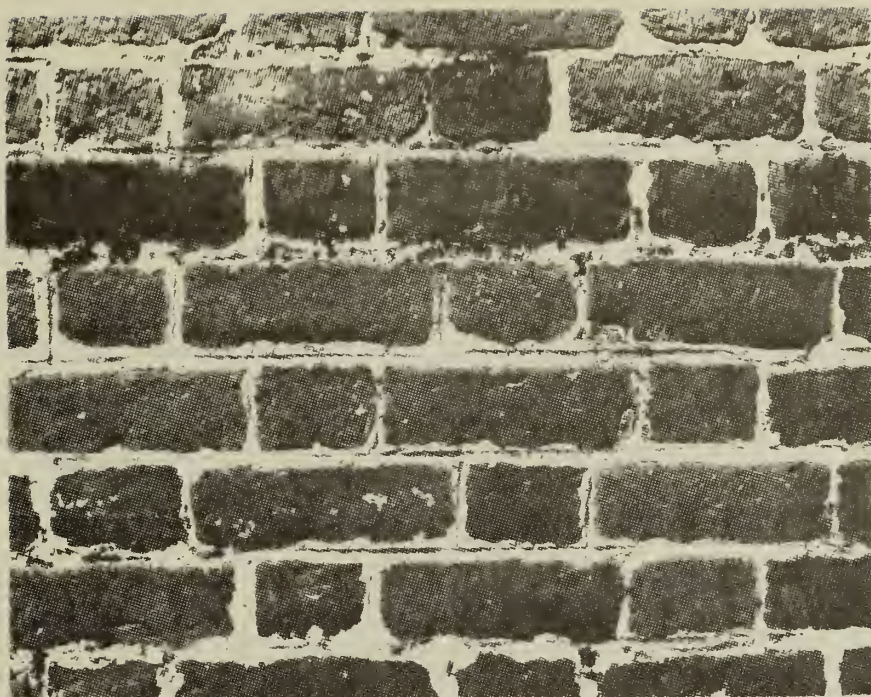
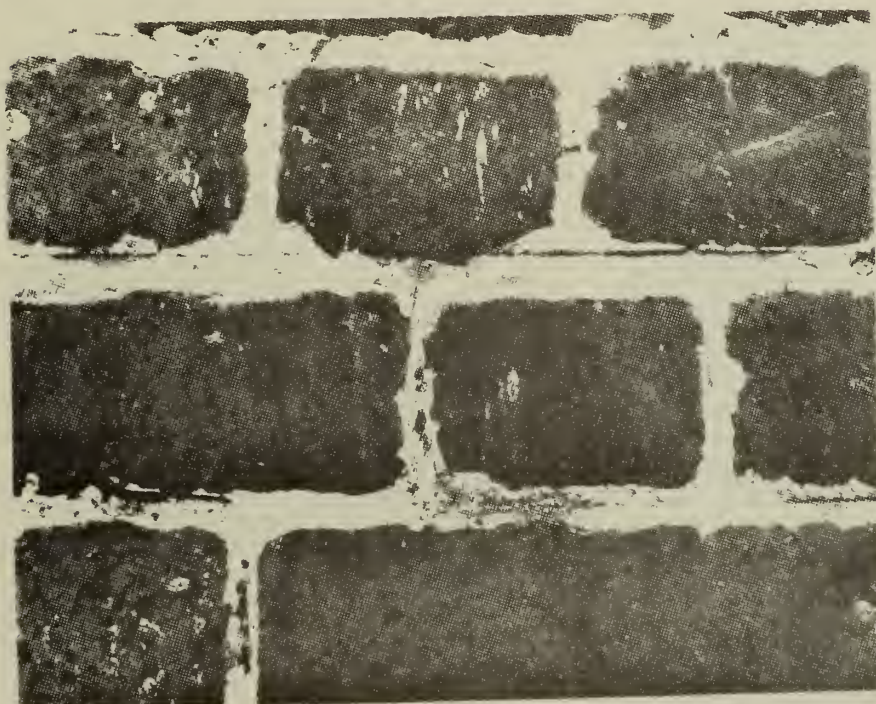
PHOTOS 22 and 22 A
Example of Pointing Dating to ca. 1830. Mortar is White Lime

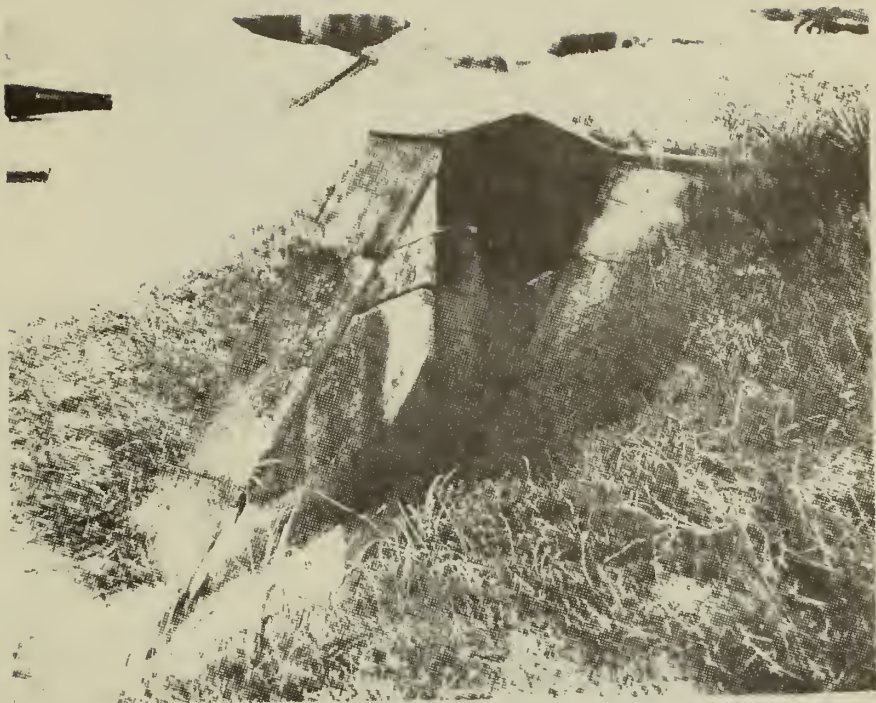
PHOTO 23

The only significant structural failures to be noted are the wing walls of Service Magazines 2 and 5 which have broken away because of foundation failure. (Photos 23 and 24)

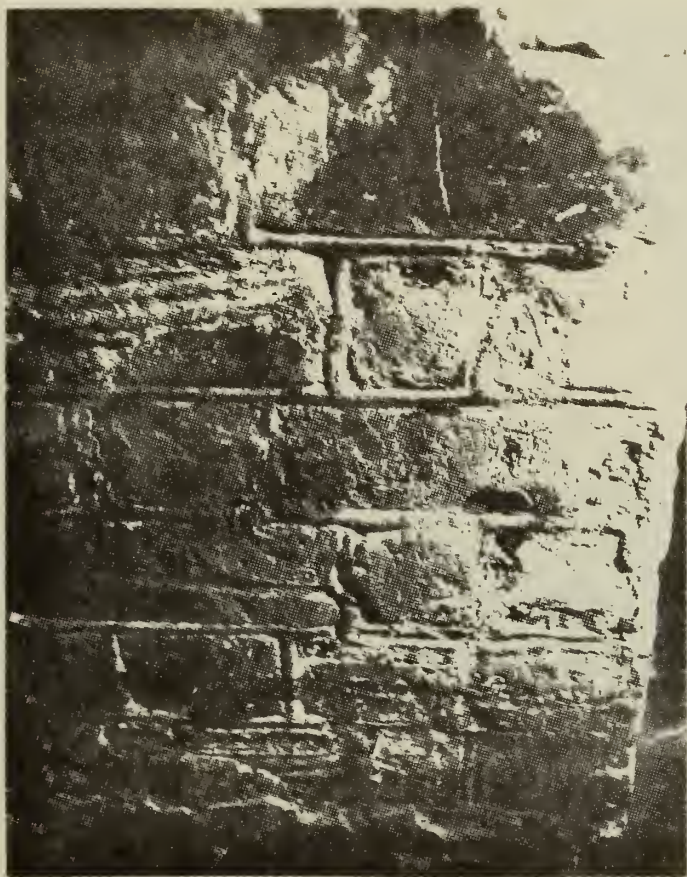
PHOTO 32

Old Pointing of North Wall of Old Storage Magazine

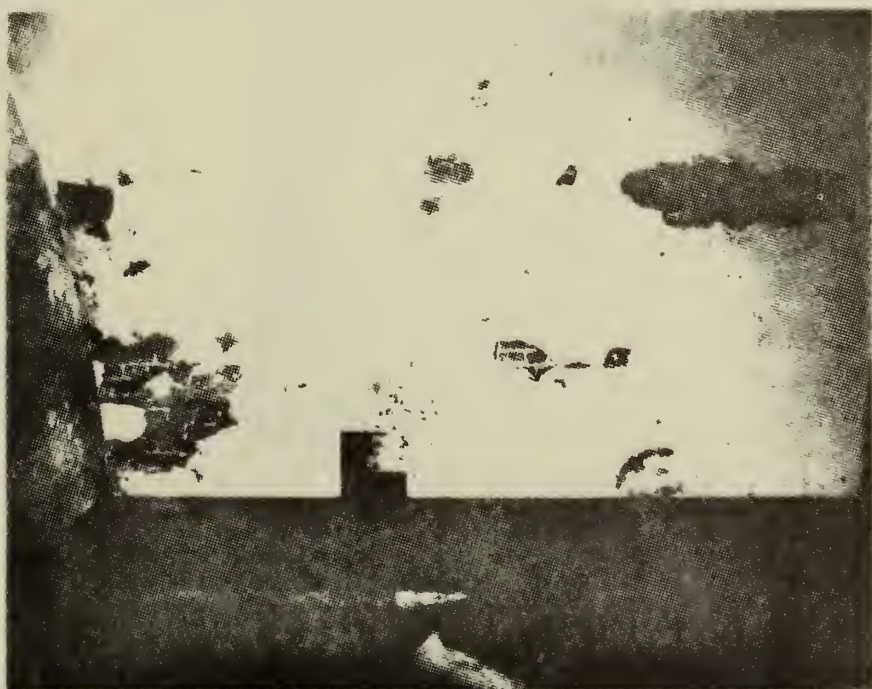
PHOTO 33

East Wall of Old Storage Magazine Anteroom, Looking East
Portion of Wall Visible at Left Margin was Original Front (South) Wall
of the Magazine

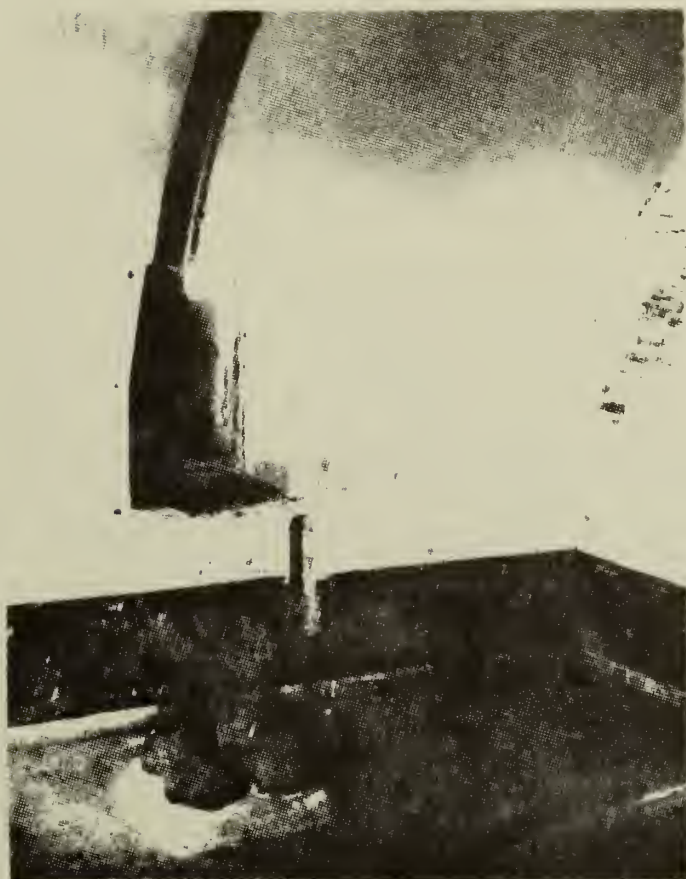
There are no visible signs of cracks or other structural failures, nor of any water-related problems except for condensation which occurs at intermittent times. The magazine is presently unlined. (Photo 34)

PHOTO 34
East Wall at Center of Magazine
